**GBA**

# BUILDING ASSESSMENT

Brentwood Community Center

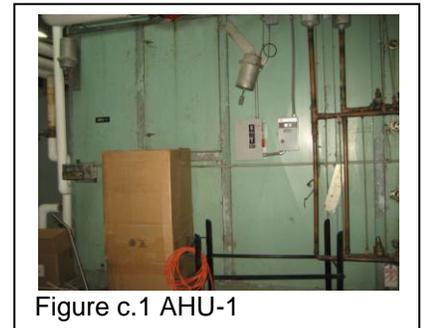
Figure c.1 AHU-1

AHU-1 (Figure c.1) is a single zone, dual deck, air handler (Air Dyne Model AH3.50M, Serial Number 2832, Cooling Capacity = 75 tons, Heating Capacity = 300 KW, 40 HP, 32000 CFM) serving the ice rink arena. The supply air is routed through metal ductwork and discharged on the east side of the ice rink arena over the bleachers. The return air is collected in a large return air plenum located just outside the ice machine room and routed underground back to AHU-

provided by an air intake hood located on the roof above unit. This intake hood also supplies outside air to AHU-2. AHU-1 and the ice rink refrigeration skid are original equipment making the equipment approximately 36 years old.

the skid and Evapco cooling tower in order to determine the age and amount of useful life remaining in the equipment. The condition of the filters for AHU-1 could not be observed.

The approximate 2010 cost to replace AHU-2 and AHU-3 is \$140,000. This cost includes new indoor air handlers of similar size, roof-mounted condensers, and new copper refrigerant piping. The cost of replacing AHU-1 and an evaporative cooling tower sized just for the air handler load is approximately \$135,000. The cost of replacing the ice rink refrigeration system is outside the scope of this project.

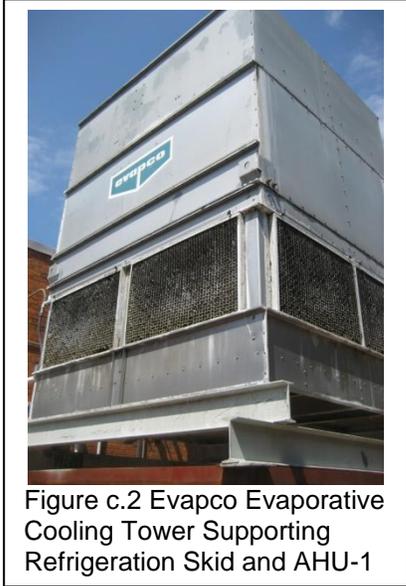
The Evapco cooling tower (Figure c.2) appears to be newer although name plate information could not be found to estimate its age. Installation occurred in 1992 according to building management. The 2007 ASHRAE Handbook – HVAC Applications (Chapter 36, Table 3) indicates the median service life for DX air distribution equipment is approximately 24 years and 22 years for metal cooling towers. However, ASHRAE service life estimates do not cover specialty equipment like the ice rink refrigeration skid. While AHU-1 appears to have been maintained well over the years, the unit is long past its useful life and should be replaced as funds become available. Since the refrigeration skid and associated equipment were not part of this building assessment scope, further investigation is recommended on

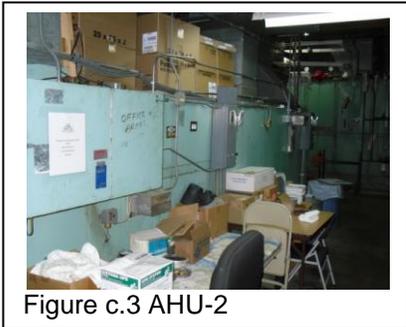
AHU-2 (Figure c.3) is a multi-zone, dual deck, air handler (Air Dyne Model ME170-RF, Serial Number 2932, Cooling Capacity = 50 tons, Heating Capacity = 190 KW, 20 HP, 16550 CFM) serving a total of six (6) zones comprised of the meeting rooms and offices in the eastern portion of the building. The temperature for each zone is controlled by a zone thermostat that adjusts the mixture of hot and cold air from the dual deck system at the air handling unit. The

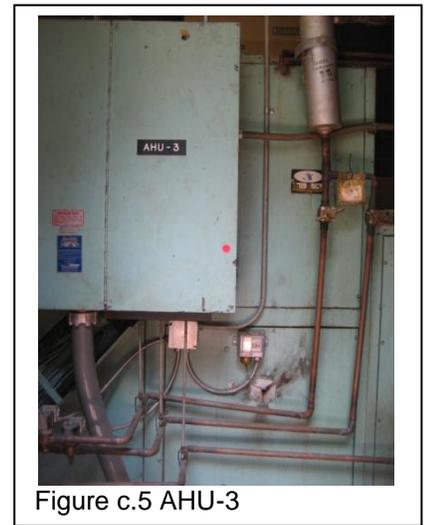
Figure c.5 AHU-3

AHU-3 (Figure c.5) is a multi-zone, dual deck, air handler (Air Dyne Model ME100-M, Serial Number 2932, Cooling Capacity = 35 tons, Heating Capacity = 190 KW, 10 HP, 10450 CFM) serving a total of four zones comprised of the lockers, warming room, meeting room, and offices in the northern portion of the building (Figure c.5). The temperature for each zone is controlled by a zone thermostat that adjusts the mixture of hot and cold air from the dual deck system at the air handling unit. The supply air for each zone is routed through separate metal ductwork to the discharge supply diffusers. The return air is collected in an overhead plenum. Cooling is provided by DX coils at the unit with a refrigerant system piped to a condensing unit, ACC-2, located on the roof (Trane Model RAUA-4001-FB, Serial Number D-10453) (Figure c.6). Heating is provided by a 190 kW duct heater located at the unit. Outside air to the unit is provided by an air intake hood located on the roof above unit. AHU-3 and ACC-2 are original equipment making the equipment approximately 36 years old. The 2007 ASHRAE Handbook – HVAC Applications (Chapter 36, Table 3) indicates the median service life for DX air distribution equipment is approximately 24 years. While both AHU-3 and ACC-2

appear to have been maintained well over the years, the units are long past their useful life and should be replaced as funds become available. The condition of the filters for AHU-3 could not be observed.

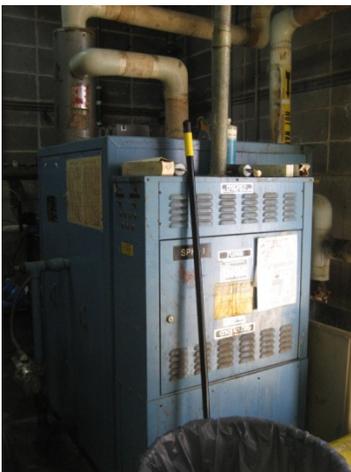
Figure c.7 Hot Water Electric Boiler SHP-1.

temperature of 100°F. SPH-1 appears to be original equipment making the boiler approximately 36 years old. The 2007 ASHRAE Handbook – HVAC Applications (Chapter 36, Table 3) indicates the median service life for a gas hot water boiler is approximately 22 years (it is assumed the same service life applies to electric boilers as well). While SHP-1 appears to have been maintained well over the years, the unit is long past its useful life. If this unit has undergone the proper maintenance over the years including replacement of the critical components, the boiler could continue to operate for some time into the future. However, if the City elects to take this course of action, the amount and condition of the boiler insulation should be investigated and potentially upgraded to improve the energy efficiency of the unit. The condition of the supply/return piping and the recirculation pump for this system was not observed.

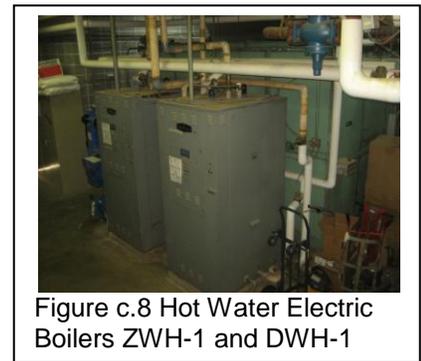
Figure c.8 Hot Water Electric Boilers ZWH-1 and DWH-1

ZWH-1 (Figure c.8) is a 200 gallon hot water electric boiler (National Steel Construction Co Model Number M2000-70, ASME Number 3E74-Y-5216, 70 kW) serving the Zamboni hot water tank filling station. DWH-1 (Figure c.8) is a 200 gallon hot water electric boiler (National Steel Construction Co Model Number M2000-50, ASME Number 3E74-Y-5217, 50 kW) serving the domestic water usage for the Community Center. Both ZWH-1 and DWH-1 appear to be original equipment making the boilers approximately 36 years old. The 2007 ASHRAE Handbook – HVAC Applications (Chapter 36, Table 3) indicates the median service life for a gas hot water boiler is approximately 22 years (it is assumed the same service life applies to electric boilers). While both units appear to have been maintained well over the years, the boilers are long past their useful life. If the units have undergone the proper maintenance over the years including replacement of the critical components, the boilers could continue to operate for some time into the future. However, if the City elects to take this course of action, the amount and condition of the boiler insulation should be investigated and potentially upgraded to improve the energy efficiency of the unit.

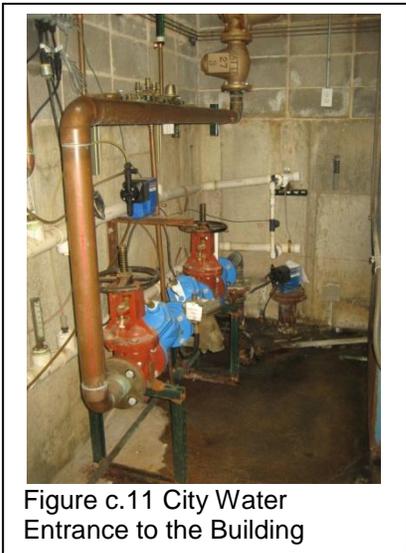
Figure c.11 City Water Entrance to the Building

The water feed (Figure c.11) for the Community Center is a 3” diameter line located in the southeast corner of the mechanical room. The water system serves the three hot water boilers, a 1-1/2” make-up water line to the evaporative cooling tower, and the potable cold water needs in the Community Center. Water services are provided by Missouri American. Plumbing drawings were not provided by the City and as a result, this building assessment contains limited information on the plumbing systems.

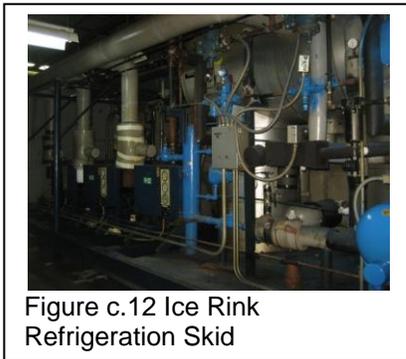
Figure c.12 Ice Rink Refrigeration Skid

The ice rink floor refrigeration skid, RRP-1 (Figure c.12), consists of three compressors, a tank, an outside evaporative cooler, and refrigerant lines serving a network of piping underneath the rink floor. The system utilizes R-22 refrigerant. The scope of this building assessment does not include an evaluation of this specialized equipment and additional investigation by the City will be necessary to determine the condition and operational effectiveness of this system.

However, based upon the age of this equipment, the City should consider replacing the equipment as funds become available. In determining the time frame for replacement, the City should also take into consideration the rising costs associated with the continued operation of an R-22 refrigerant based system (refer to the above discussion of potential price increases due to the current phase-out of

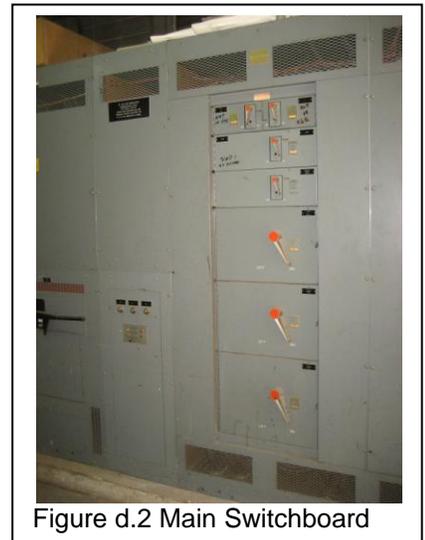
Figure d.2 Main Switchboard

The building electrical service voltage is 277/480 volt, 3 Ph, 4 Wire with dual metering for separate heating and general service usage. The main switchboard has a 1600 amp incoming bus with two (2) main switches: a general service main switch rated at 800 amps and the heating service main at 1200 amps which is equipped with ground fault protection as required by code. The building heat is 100% from electric resistance heating. The switchboard is original equipment made by Federal Pacific Electric (FPE), installed 1974 with no apparent modifications to it. The overall condition of the main switchboard (Figure d.2) appears to be well maintained and is adequate for the existing building in its current function.

FPE is no longer in business and replacement parts are not readily available, so used or rebuilt replacement parts would need to be utilized. This is also of concern if modifications to the building will require different size switches than currently exist in the switchboard. Modifications to the building would require the existing service and switchboard be brought up to current code making the total amperes of the main switches equal the bus ampere rating. The service entrance conductors are currently rated for 1,520 amps and should have the same capacity as the main switches (2,000A

total) per current code. Due to the age and lack of availability of new replacement parts, the main switchboard should be replaced or upgraded when modifications to the building are made. Opinion of probable cost for this improvement is \$50,000.00

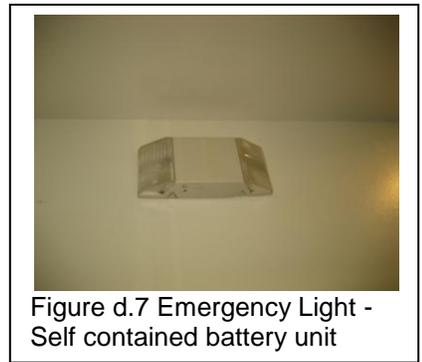
Figure d.7 Emergency Light - Self contained battery unit

Emergency lighting (Figure d.7) in the building exists, but does not meet current code requirements. The emergency lighting panels ELP-1 and EPL-2 are original Siltron battery (Figure d.8) inverters and were not tested to determine if they function properly. A limited number of self contained battery units that have been added since the building was constructed. These should be tested to confirm their functionality. **GBA recommends the addition of emergency lighting.** Opinion of probable cost for this improvement is \$7,500.00

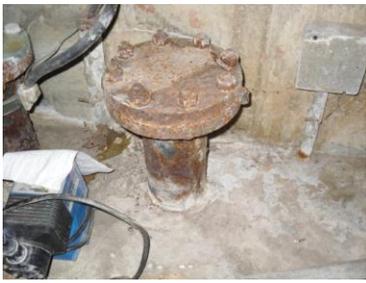
Figure e.1 Water Entrance

Original construction documents show a possible plan for a future fire sprinkler system using the existing 4” water supply entrance pipe (Figure e.1) which exists in the mechanical equipment room adjacent to the domestic water entrance. The condition of the underground pipe for the spare 4” water entrance is unknown. If building expansions or additions are pursued a new water main could be brought in and riser located in the new expansion to avoid disturbing

existing footings and slab. Installation of a new fire sprinkler system will most likely require larger size pipe than the 4” existing water entrance. **GBA does not recommend using the existing 4” water entrance for fire sprinklers.**

A new water line from the city main into the building is recommended. The existing water supply pressure and flow is assumed to be adequate for adding fire sprinklers without the use of a fire pump by a comparison of surrounding sprinkler protected buildings. Probable cost for the installation of a new Fire Sprinkler system is estimated at \$6/sf which totals approximately \$240,000 for the existing building.

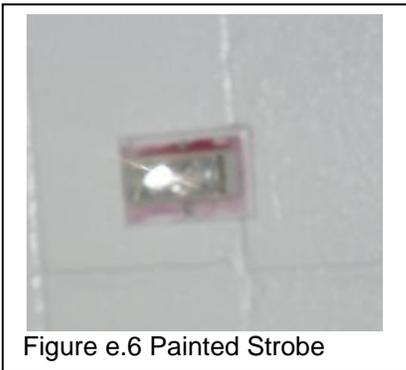
Figure e.6 Painted Strobe

The building is required to have an emergency voice/alarm communication system due to the occupant loading. This will require replacement of existing occupant notification system including strobes, horn/strobes, and notification power supply. The existing fire alarm panel could remain and communicate with the emergency voice/alarm communication system. If the building is fully sprinklered, the manual pull stations could be removed.

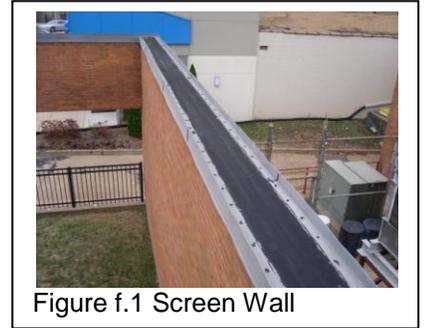
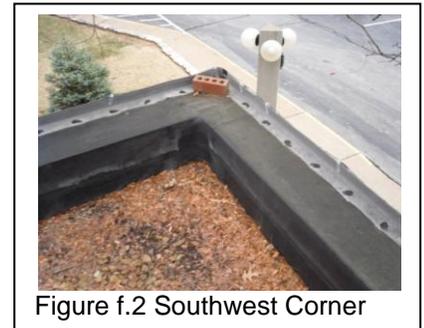
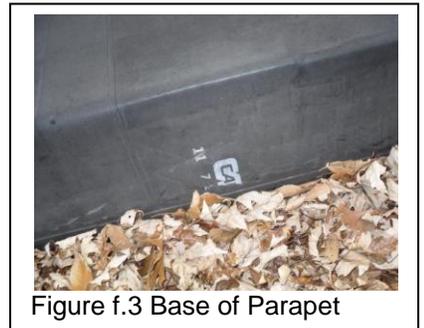
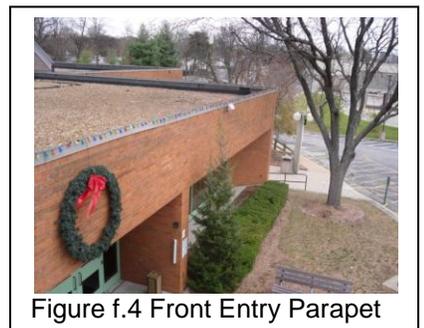
The existing roof is a 45 mil EPDM Ballasted Roof manufactured by Carlisle, and installed after November 22, 1988 (Figure f.1-14). GBA confirmed age of the roof with John Lucas, a Carlisle manufacturer representative in the St. Louis area. Mr. Lucas determined the roof installation most likely occurred in 1989 based on a printed code found on the membrane (Figure f.15). A roof patch dated 8-18-04 probably denotes a repair date of the roof membrane (Figure f.16). Building management confirmed the roof was originally installed in February 1989. Repairs occurred in 1991, 1993, 1996, 1997, 1999, 2004, 2005, 2008, and 2010.

The 15-year warranty for the roof membrane expired in 2004. The existing ballast appears very coarse; not in the required densities. Round river rock is recommended for a ballasted roof system. There are many locations where ballast is inadequate or needs supplemental material to meet the manufacturer's recommended density (lbs/sf) in the corners, perimeter and field. Necessary maintenance and repair has extended the roof lifespan to approximately 22 years. **With new technologies for roofing materials, GBA recommends, that the roof be replaced with a more energy efficient membrane.**

Opinion of probable replacement cost for both roofs (ice rink and administration) without replacement of the insulation would be approximately \$7 to 8/sf. With approximately 40,100 sf of roof area, the cost for materials and labor to remove and replace with new membrane would be approximately \$280,000 to \$320,000. If the insulation has to be replaced, this would add approximately \$80,000 to the above number for a total of approximately \$360,000 to \$400,000.

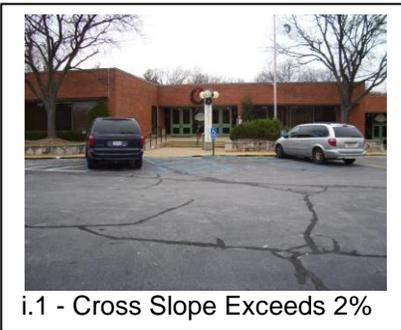
Existing cross slope of handicap spaces near entrance exceeds the allowable 2% according to ADA requirements (Figure i.1). The cross slopes of these spaces falls from south to north. These three (3) spaces are located near the center entrance of the recreational facility.

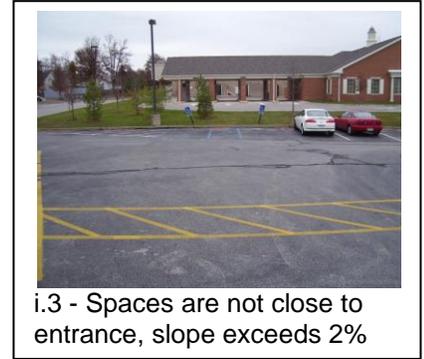
The remaining two (2) handicap spaces are located in the northeast corner of the parking lot of the recreational facility, northeast of the entrance doors to the ice rink and the drop off zone to the ice rink (Figure i.3). To access the ice rink from these parking spaces, individuals are required to cross a drive aisle and the ice rink drop off zone. Pavement slopes from these spaces exceed the allowable 2% slope and travel distance is approximately 135 feet from the northernmost door of the facility (ice rink entrance).

i.3 - Spaces are not close to entrance, slope exceeds 2%

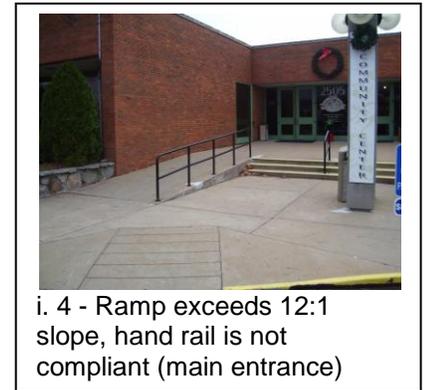
The ramp at the main entrance from the parking area to the sidewalk is not level to provide the required landing area (Figure i.4). In addition, the ramp from the sidewalk up to the area level with the entrance doors exceeds a 12:1 slope and does not meet ADA requirements. Also, the existing handrail does not meet current ADA requirements.

i. 4 - Ramp exceeds 12:1 slope, hand rail is not compliant (main entrance)

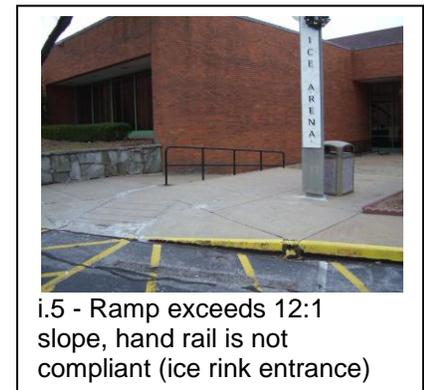
At the northern-most entrance of the facility, the ramp from the parking area to the sidewalk is not level to provide the required landing area (Figure i.5). In addition, the ramp from the sidewalk down to the area level with the entrance doors exceeds a 12:1 slope which is required to meet ADA requirements. Also, the existing handrail does not meet current ADA requirements.

i.5 - Ramp exceeds 12:1 slope, hand rail is not compliant (ice rink entrance)

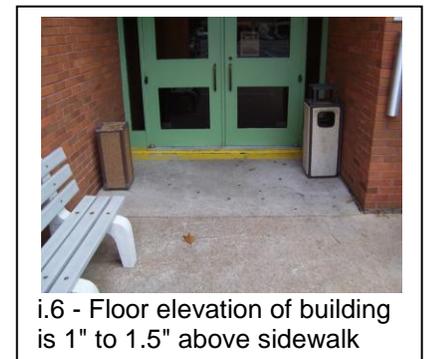
The ramp from the parking area to the sidewalk is not level to provide the required landing area. It also appears that the sidewalk in front of the doors has settled causing a 1" to 1.5" elevation difference between the finish floor of the facility and the entrance sidewalk at the doors (Figure i.6). This has caused a potential trip hazard, as well as being inaccessible for wheelchairs.

i.6 - Floor elevation of building is 1" to 1.5" above sidewalk

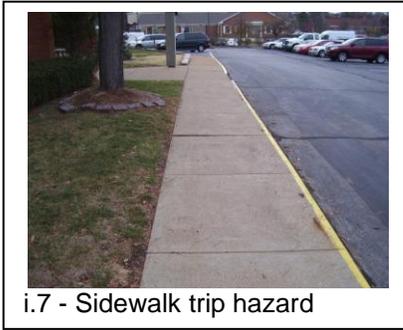
i.7 - Sidewalk trip hazard

Currently, there is a 4' foot sidewalk adjacent to the recreational facility's transition between the parking lot and building structure. Most of the sidewalk is in good condition with the exception of an elevation differential between two (2) slabs on the east side of the facility. This differential is likely caused by tree roots (Figure i. 7).

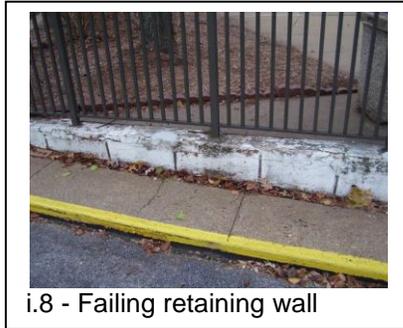
i.8 - Failing retaining wall

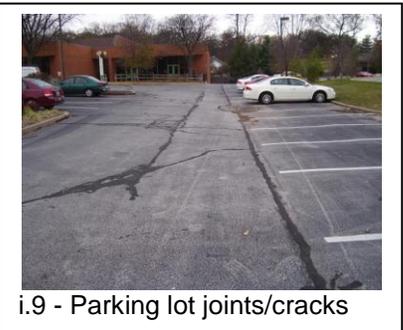
i.9 - Parking lot joints/cracks

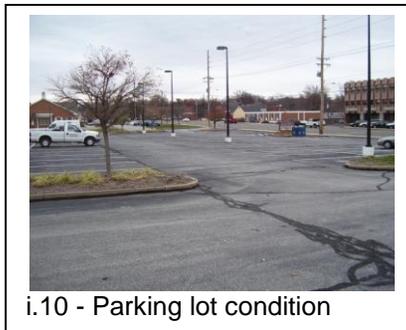
The general condition of the existing asphalt parking lot is in fair to good condition. With routine maintenance consisting of crack sealing, patching and the occasional milling and overlay, the parking lot is capable of serving the existing facility for the foreseeable future. **However, GBA recommends improvements to the deficiencies found with accessibility and the building exterior.**

i.10 - Parking lot condition

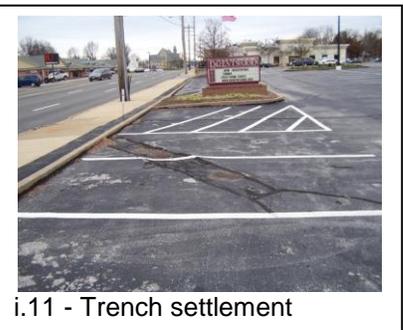
i.11 - Trench settlement

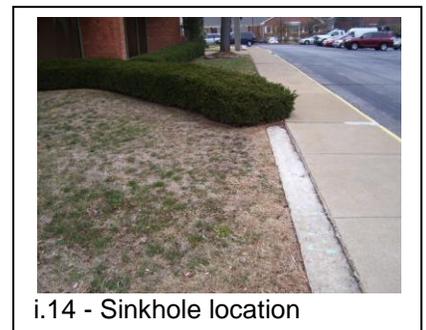
The original construction documents identify a sinkhole (Figure i.14) near the southeast corner of the building. According to the construction documents, a drain was to be constructed above the sinkhole to drain storm water from the landscaped area above the sinkhole.
