MANCHESTER ROAD CORRIDOR REDEVELOPMENT AREA

2023 CHAPTER 353 QUALIFICATIONS ANALYSIS

CITY OF BRENTWOOD, MISSOURI

JUNE 12, 2023

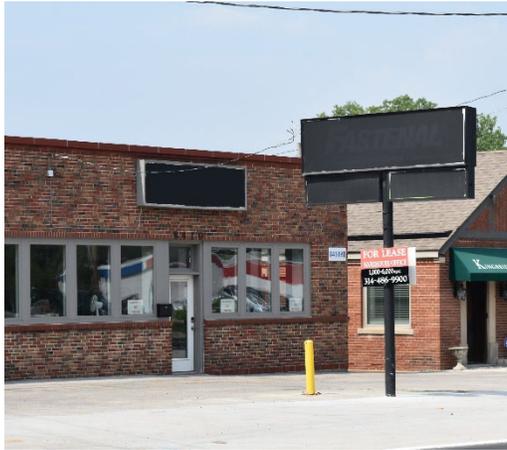
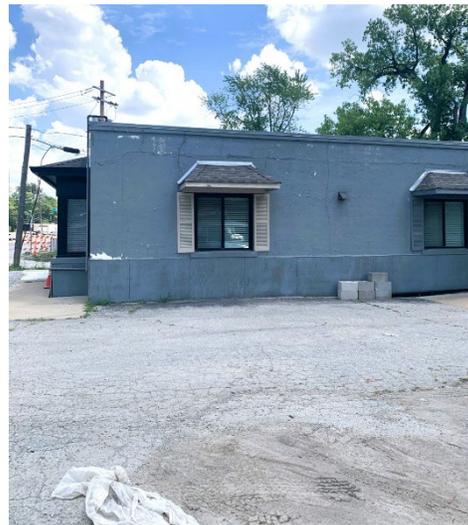
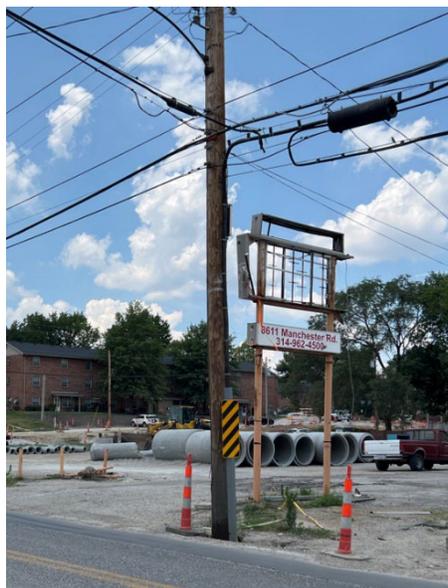
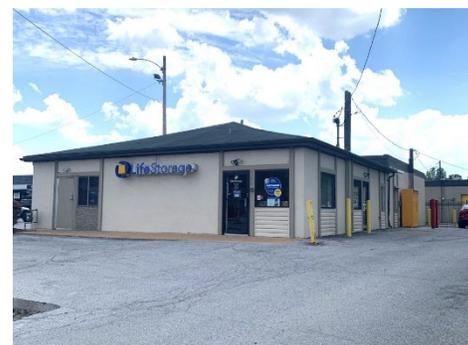
The building at the upper right appears to be vacant. The heavily tinted windows are a detriment to its appearance and impede the ability of police to recognize illicit activity within the building. Like other buildings in the Area, it suffers from physical deterioration from deferred maintenance of both building elements and parking areas.

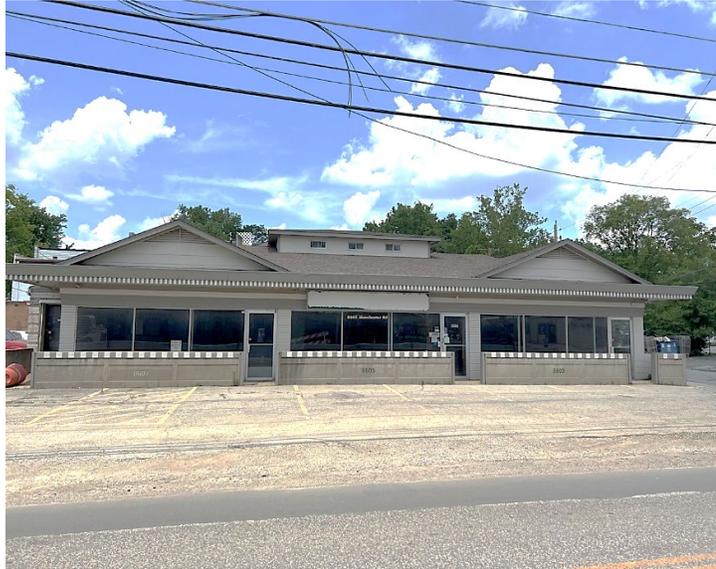
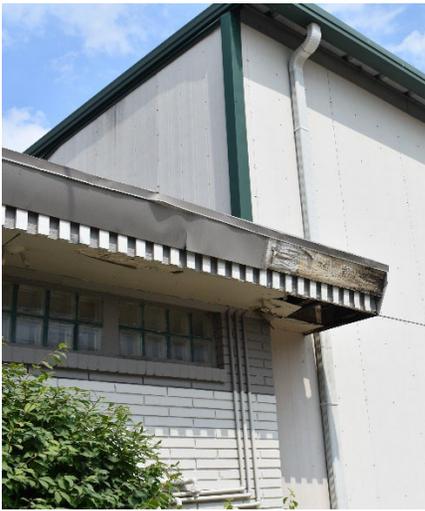
The same is true of the building at center right, however its parking areas are in worse condition as can be seen in the large pothole at the lower left and the extensive alligator cracking of the parking lot.

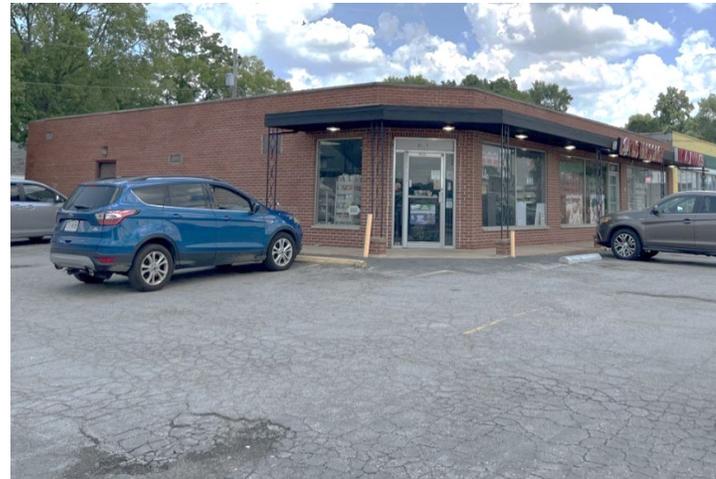
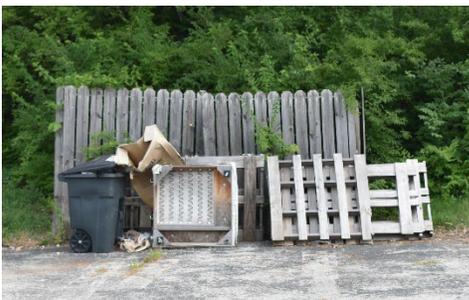
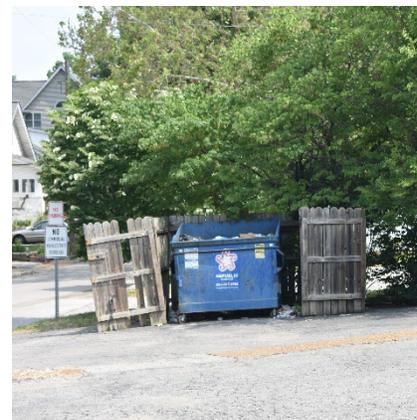
The trash enclosures (left and right) are among several in the area that are essentially falling apart and the area around the trash container is

scattered with trash. This represents an unhealthy condition that breeds vermin. The trash in the left photo has been there since 2018.

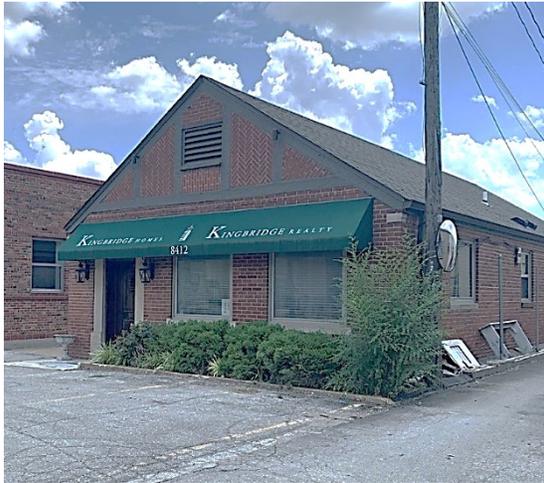
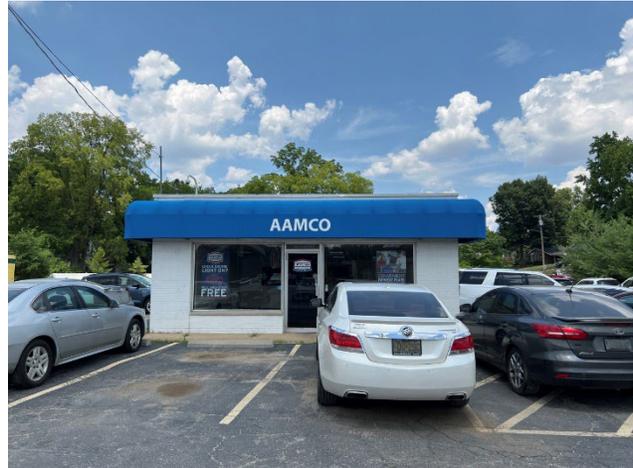
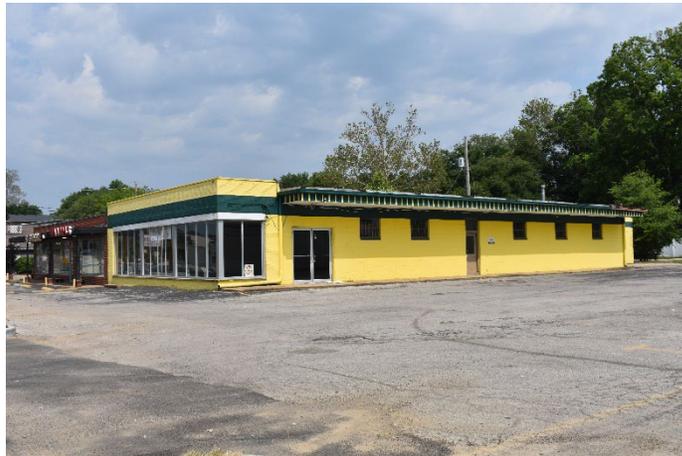
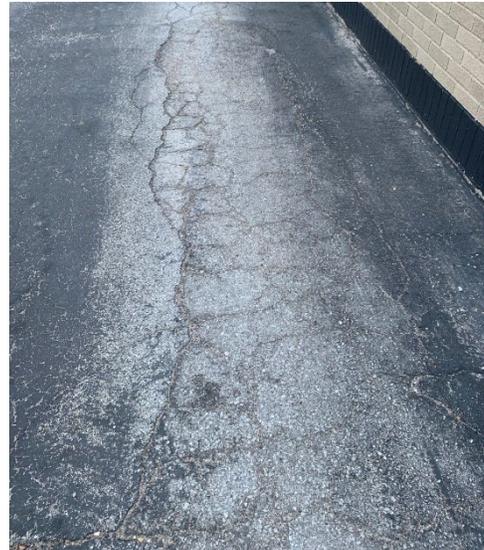
The trash alongside the building at the upper left is still there today. The building above previously housed a lawn care equipment dealer that was vacant prior to the 2018 site investigations and is still vacant today.

These photos along the right represent typical parking area conditions as well as building conditions. Close inspection reveals deteriorating painted surfaces on all the buildings on this page.

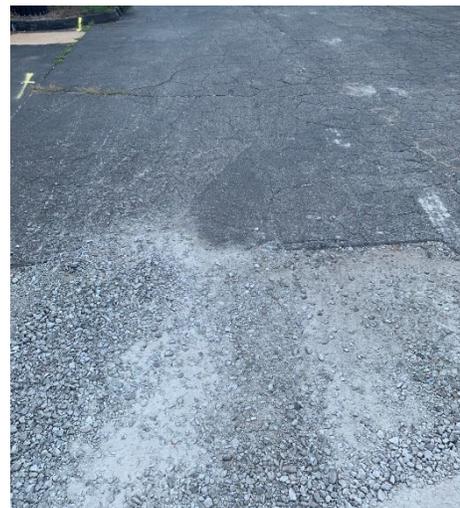
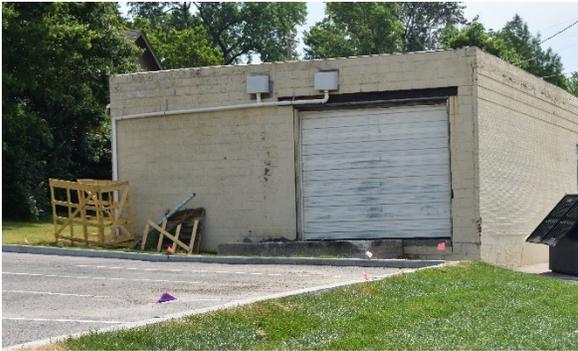
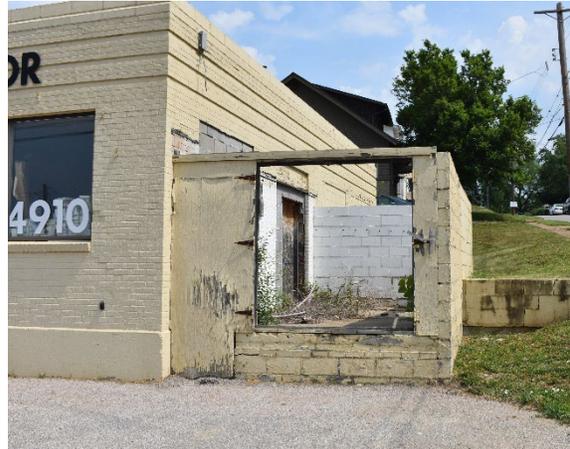
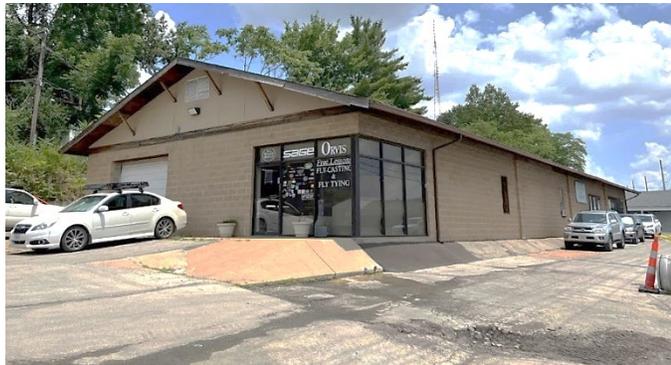
These photos below (right) represent properties that present a reasonable appearance but each of which have physical deterioration that, if not addressed, will get worse. This includes deterioration of painted surfaces (walls, soffits, fascia boards, etc.).

They each have deteriorating parking areas, like nearly every other property in the area.

The buildings in the top and middle photos also have deteriorating window frames.

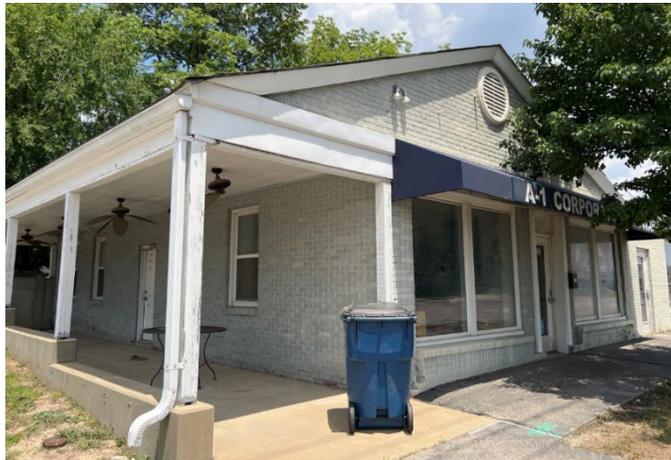
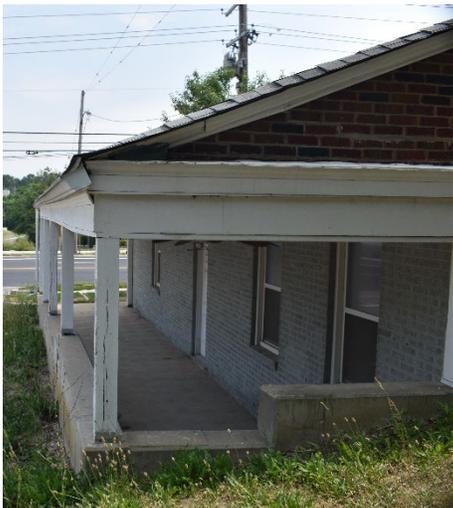
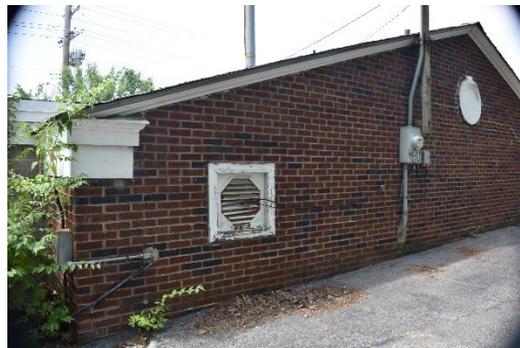
These photos represent properties at the eastern end of the Area (bottom) and near the middle (top and middle). The top two photos are on the south side of Manchester Road and upon close inspection will that demonstrate the a “water line” that show the teltale evidence of prior flooding. The bottom two photos show the evidence ot lingering trash collection and aligator cracking parking lot conditions (as shown in photots from properties in the western end of the area) that are prevalent throughout the area.

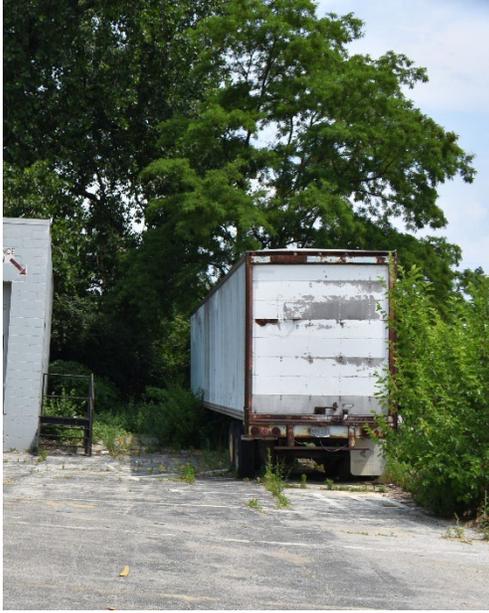
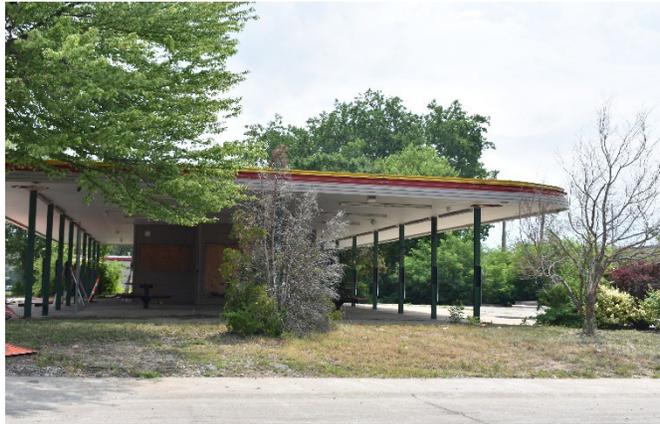
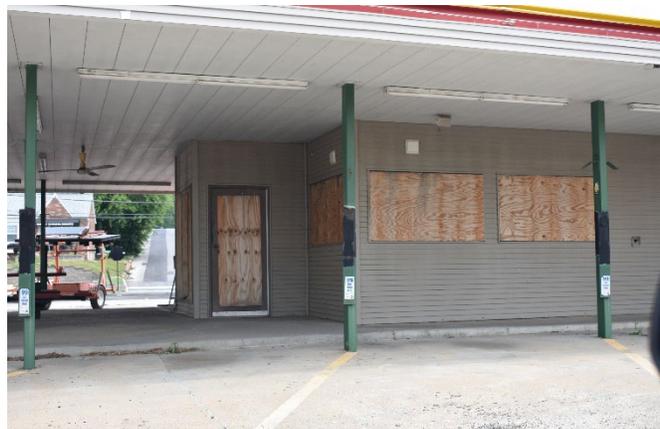
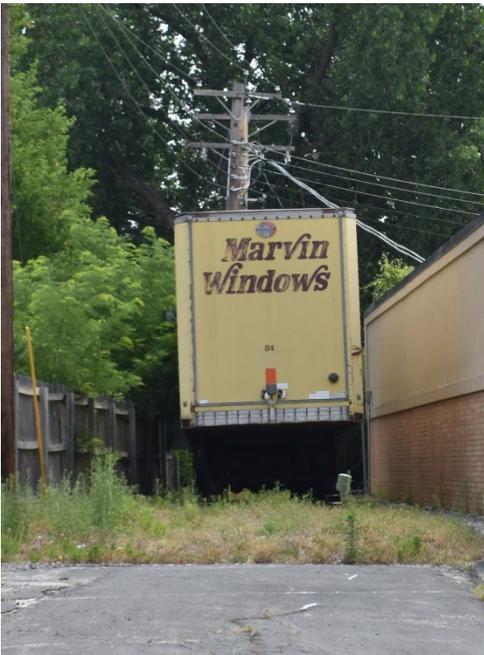
The trailers (photos to the upper left, left, and right) are examples of equipment on various sites that have not been moved in years. It is not known if these are being used for storage.

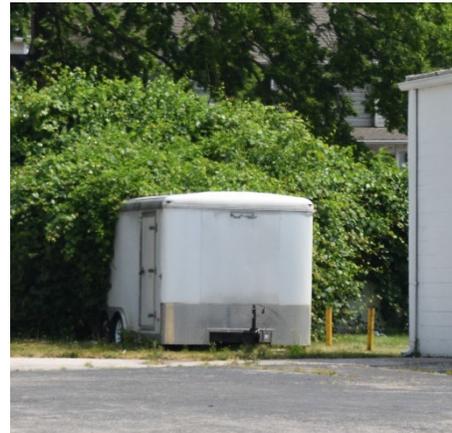
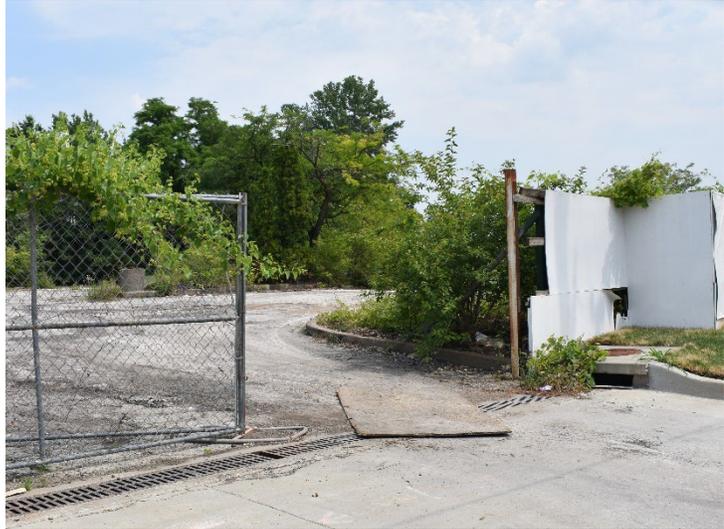
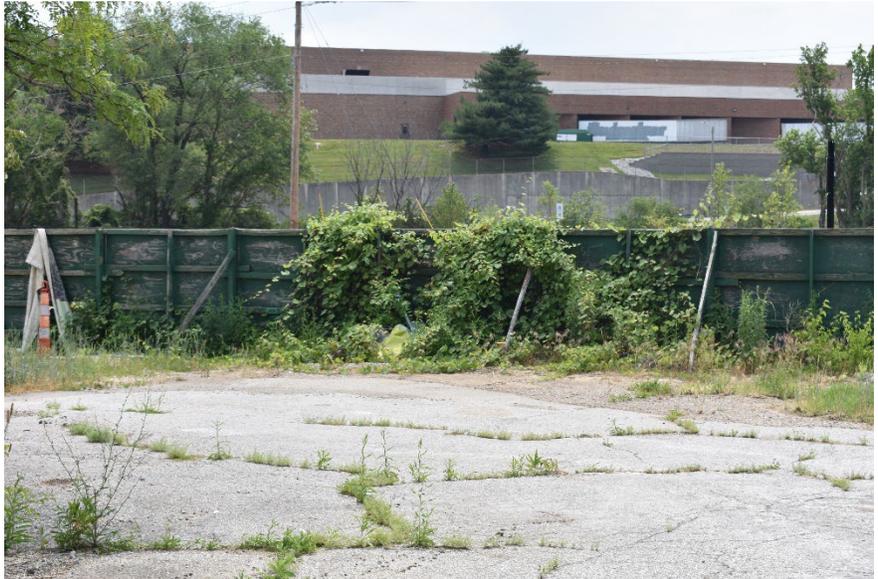
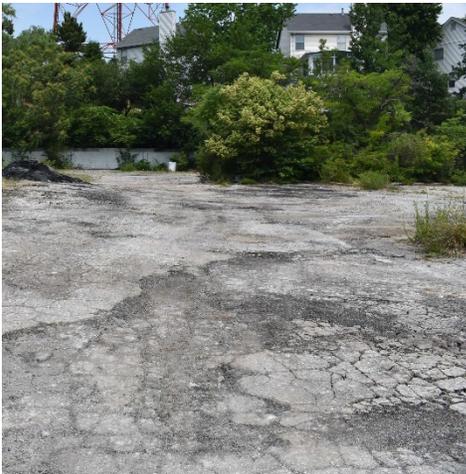
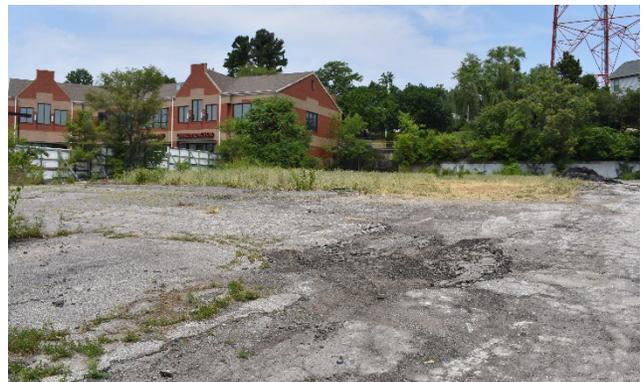
This property is located on the northwest side of Manchester Road at its intersection with Hanley Road. During previous site visits (2018 and 2022) this entry was secure, albeit not thoroughly. The most recent site visit shows this entry to be completely open.

As the photos show, this property is vacant and in deteriorated condition. Site paving is badly deteriorated, it is overgrown, and the remaining perimeter fencing is in bad condition as well.

The site photo below at the bottom left is a densely overgrown area which indicated the likely existence of a campsite.

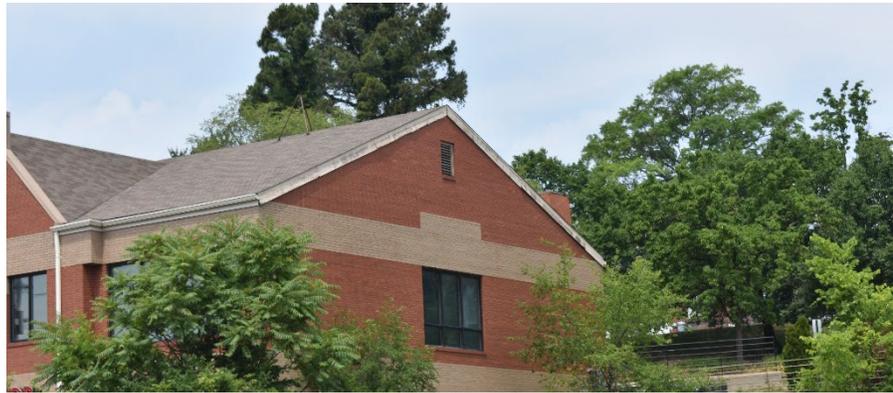
This top photo show that even some of the newest buildings in the area are beginning to show signs of minor deterioration and need paint or other tupes of repairs,.

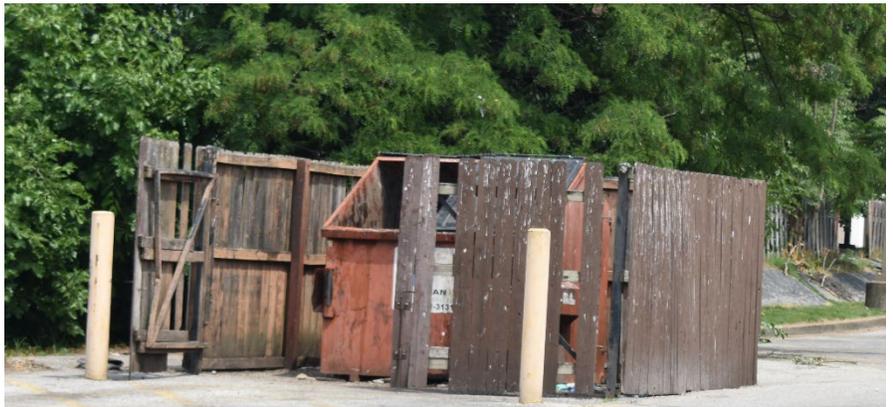
Here is yet another trash inclosure that is falling apart.

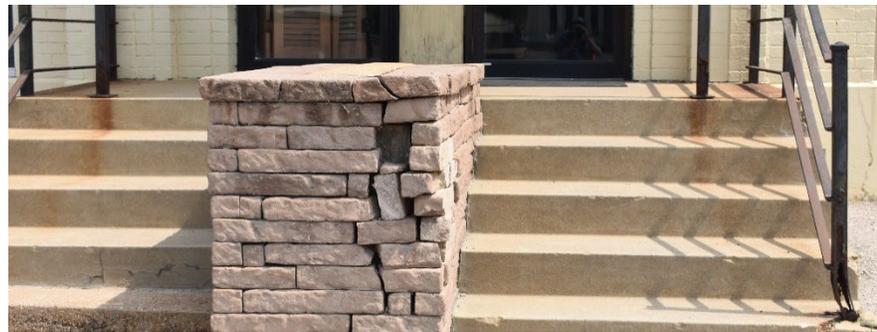
This is at the entrance to another building,

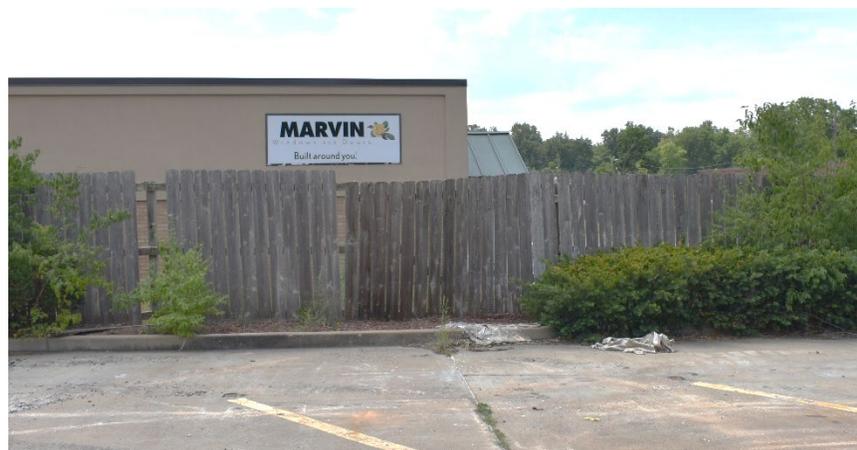
Virtually all the wood faced fencing throughout the Area is deteriorated with missing boards, sections, or is otherwise damaged.
