**GBA**

# BUILDING ASSESSMENT

Brentwood Community Center

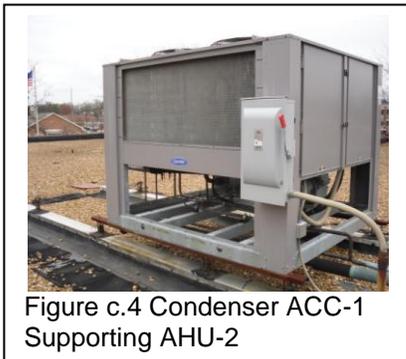
AHU-2 (Figure c.3) is a multi-zone, dual deck, air handler (Air Dyne Model ME170-RF, Serial Number 2932, Cooling Capacity = 50 tons, Heating Capacity = 190 KW, 20 HP, 16550 CFM) serving a total of six (6) zones comprised of the meeting rooms and offices in the eastern portion of the building. The temperature for each zone is controlled by a zone thermostat that adjusts the mixture of hot and cold air from the dual deck system at the air handling unit. The

supply air for each zone is routed through separate metal ductwork to the discharge supply diffusers. The return air is collected in plenums and routed back to AHU-2. Cooling is provided by DX coils in the unit with a refrigerant system piped to a condensing unit ACC-1 (Figure c.4), located on the roof (Carrier Model 38AH-054-621, Serial

Number 1407Q08235). Heating is provided by a 190 kW duct heater located at the unit. Outside air to the unit is provided by an air intake hood located on the roof above unit. This intake hood also supplies outside air to AHU-1. AHU-2 is original equipment making the unit approximately 36 years old. The Carrier condensing unit was manufactured in 2007 and is three (3) years old. The 2007 ASHRAE Handbook – HVAC Applications (Chapter 36, Table 3) indicates the median service life for DX air distribution equipment is approximately 24 years. While AHU-2 appears to have been maintained well over the years, the unit is long past its useful life and should be replaced as funds become available. ACC-1 is only three years old and can be utilized for a while longer with proper maintenance, although consideration of refrigerant R-22 phase out should be considered (see below). The condition of the filters for AHU-2 could not be observed.

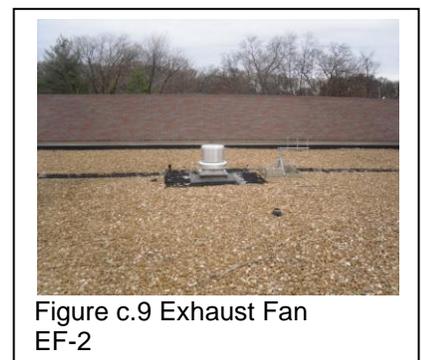
Figure c.9 Exhaust Fan EF-2

Three (3) exhaust fans are located in the Community Center: EF-1 serves the restroom located next to the meeting room 103, EF-2 (Figure c.9) serves the men’s and women’s restrooms located in the

eastern portion of the building, and EF-3 serves the locker rooms, dressing rooms, and electrical room in the northern part of the building.

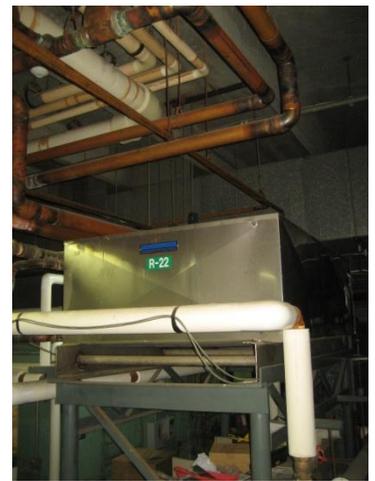
Figure c.13 Heat Recovery System Heat Exchanger

A heat recovery system was installed in 1994 to transfer heat from the higher temperature refrigerant suction lines of the ice rink refrigeration system to a new, supplemental hot water system (Figure c.13 -14). The heat recovery system equipment included two new heat exchangers, a 140 gallon storage tank, and three recirculation pumps. The hot water generated from the heat recovery system provided “free” hot water to a new reheat coil in AHU-1 and the three hot water boilers systems. The scope of this building assessment does not include an evaluation of this specialized equipment and additional investigation will be necessary to determine the condition and operational effectiveness of this system.

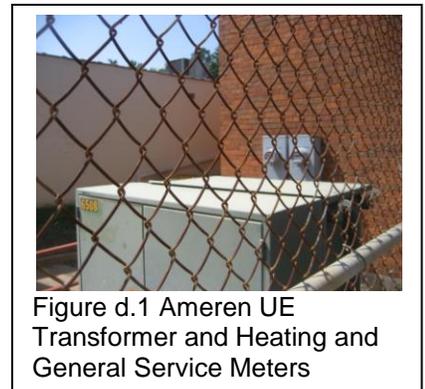
Figure d.1 Ameren UE Transformer and Heating and General Service Meters

The entire facility is supplied through a single underground electrical service. The main switchboard is located in the building mechanical equipment room on the south end of the building. The local utility (Ameren UE) transformer (Figure d.1) is located on a pad adjacent to the building east of the mechanical equipment room on the south end of the building.

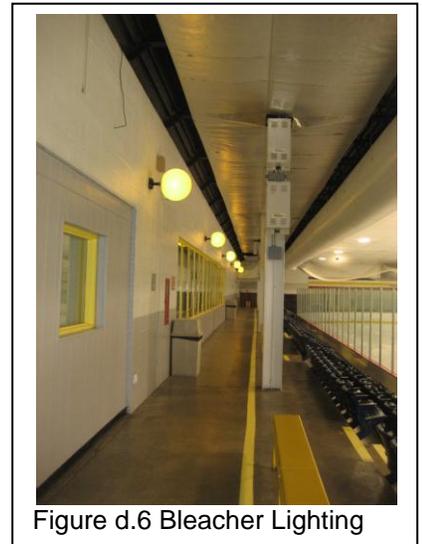
Figure d.6 Bleacher Lighting

with the exception of the HID fixtures in the ice arena which are 277V. Corridors are poorly lit and may be below recommended lighting levels (Figure d.5). The ice rink lighting is metal halide HID and appears to be adequate. The lighting for the bleachers in the rink are original fixtures with yellowed lenses (Figure d.6). Exterior accent and site lighting was not operating during the daytime, but appears to be original; light level readings were not collected.

**upgrades to install high efficiency lighting and controls are recommended.** Probable cost for this improvement is \$96,000.00.

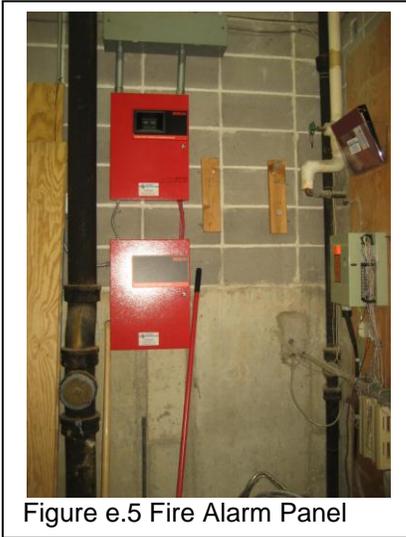
Figure e.5 Fire Alarm Panel

The facility is equipped with a fire alarm system. The fire alarm panel - BOSCH D7024 (Figure e.5) is located in the mechanical equipment room. Fire alarm manual pull stations are located at all exits. Spot smoke and heat detectors are selectively located.

Duct smoke detectors are located on the supply and return side of the three HVAC units. The fire alarm system monitors the kitchen hood suppression system. Occupant notification exists throughout in the form of horn/strobes and strobes and is connected to a remote notification power supply, BOSCH D7038. Notification device types and models vary throughout. Strobes are provided in restrooms. The candela and decibel ratings could not be verified for proper coverage and synchronization. It was noted that one (1) fire alarm strobe has been painted and should be replaced (Figure e.6). Probable cost for the installation of a new Fire Alarm System is estimated at \$1/sf which totals approximately \$40,100 for the existing building.

The building is required to have an emergency voice/alarm communication system due to the occupant loading. This will require replacement of existing occupant notification system including strobes, horn/strobes, and notification power supply. The existing fire alarm panel could remain and communicate with the emergency voice/alarm communication system. If the building is fully sprinklered, the manual pull stations could be removed.

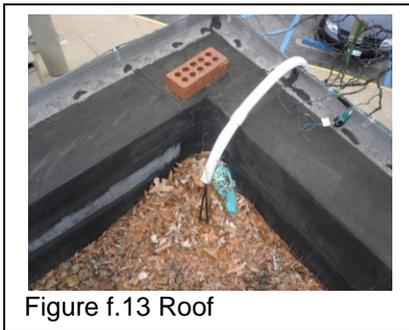
Figure f.13 Roof

The existing roof is a 45 mil EPDM Ballasted Roof manufactured by Carlisle, and installed after November 22, 1988 (Figure f.1-14). GBA confirmed age of the roof with John Lucas, a Carlisle manufacturer representative in the St. Louis area. Mr. Lucas determined the roof installation most likely occurred in 1989 based on a printed code found on the membrane (Figure f.15). A roof patch dated 8-18-04 probably denotes a repair date of the roof membrane (Figure f.16). Building management confirmed the roof was originally installed in February 1989. Repairs occurred in 1991, 1993, 1996, 1997, 1999, 2004, 2005, 2008, and 2010.

The 15-year warranty for the roof membrane expired in 2004. The existing ballast appears very coarse; not in the required densities. Round river rock is recommended for a ballasted roof system. There are many locations where ballast is inadequate or needs supplemental material to meet the manufacturer's recommended density (lbs/sf) in the corners, perimeter and field. Necessary maintenance and repair has extended the roof lifespan to approximately 22 years. **With new technologies for roofing materials, GBA recommends, that the roof be replaced with a more energy efficient membrane.**

Opinion of probable replacement cost for both roofs (ice rink and administration) without replacement of the insulation would be approximately \$7 to 8/sf. With approximately 40,100 sf of roof area, the cost for materials and labor to remove and replace with new membrane would be approximately \$280,000 to \$320,000. If the insulation has to be replaced, this would add approximately \$80,000 to the above number for a total of approximately \$360,000 to \$400,000.

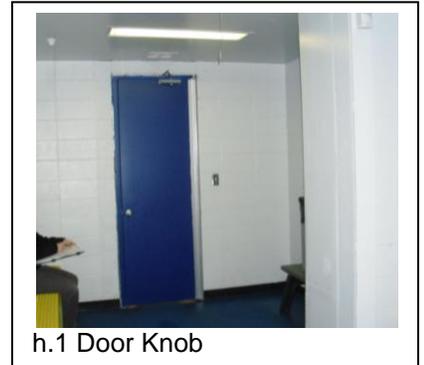
- Door Handles –

In many rooms, doors have a knob type handle that do not comply with ADA. A rough estimate of the number of doors effected totals 82. These doors need a lever type of handle installed that meets ADA standards. The cost estimate for durable, lever handles is \$320 per door or approximately \$26,240 for updating the existing doors.

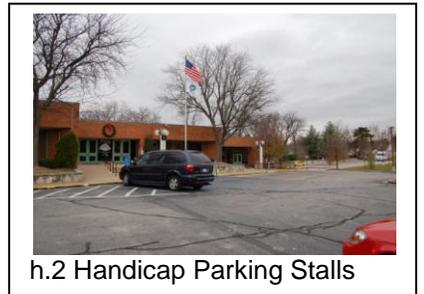
- Handicap Parking Stalls –

ADA requires a slope of less than 2% across accessible parking stalls. The existing stalls have a greater than 2% slope and will require a correction in grading. At the time of construction, further evaluation of the the number, size, and location of handicap stalls will need to be conducted based on the final design. Probable cost for this improvement is estimated in Task Seven.

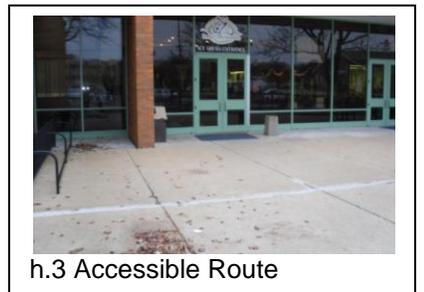
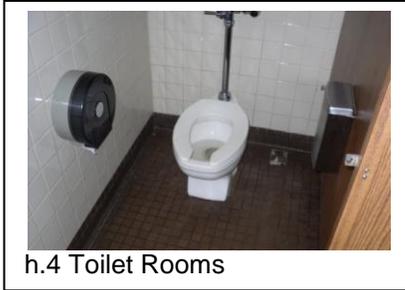
- Accessible Route Into the Building –

The ramps, steps, and stair handrail do not meet ADA standards. Probable cost for this improvement is estimated in Task Seven.

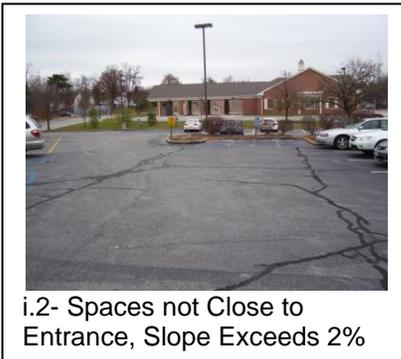
One (1) of the relocated handicap parking spaces has been placed near the landscaped area in the parking lot, east of the entrance of the ice rink, drop off area and drive aisle (Figure i.2). The pavement slope of this parking space exceeds the allowable 2% slope. Furthermore, the parking space is approximately 105 feet from the nearest entrance (main entrance) of the facility.

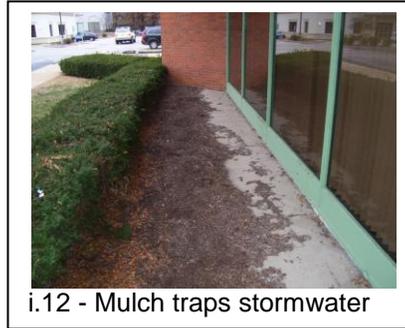
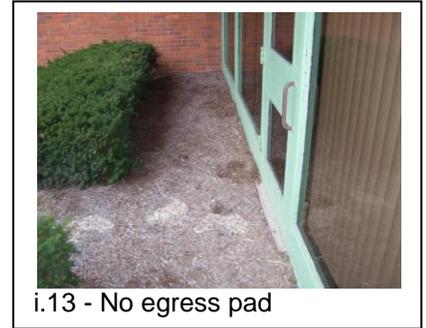
The landscaped areas along the front southern portion of the building is elevated above the finish floor elevation of the structure and potentially traps water between the building the landscaped areas (Figure i.12-13). In addition, an egress door from a meeting room does not provide a landing pad on the exterior. A minimum of a 4' x 4' paved pad is required on the exterior of all egress doors.
